Quantifying 250 years of change to the channel structure of the River Kelvin

Isabel Moore^{1,2}, Caroline McGillivray³, William E. Yeomans³, Kevin Murphy¹

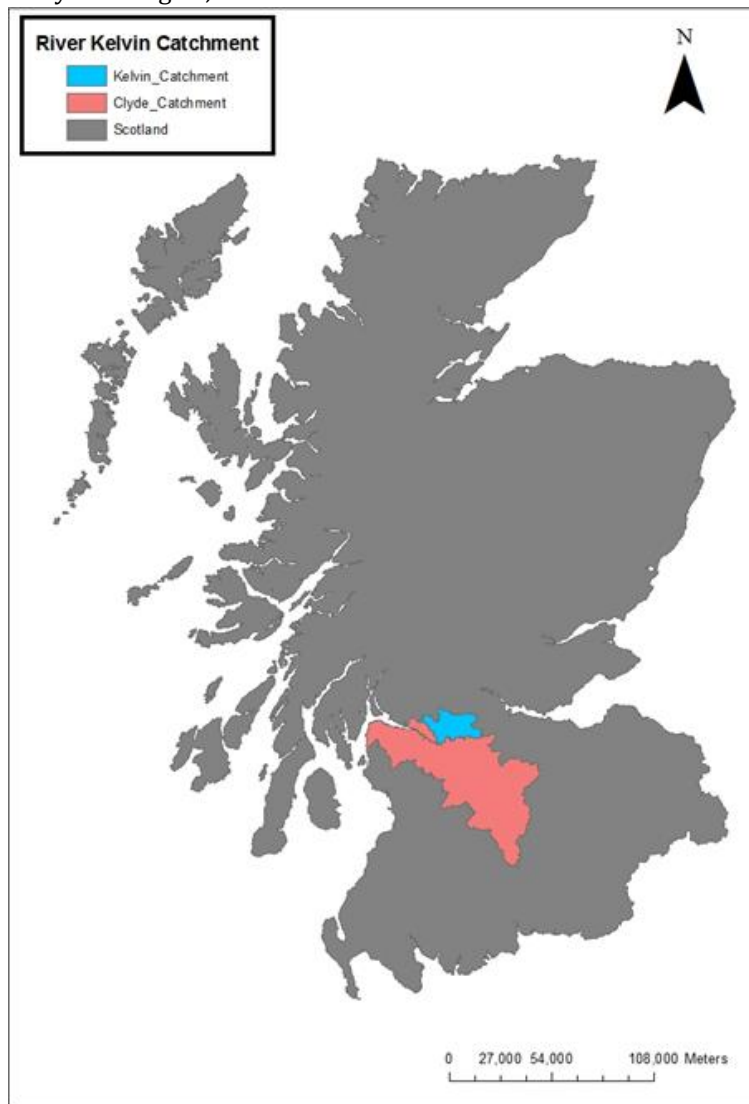
Fig. 1. Map of Scotland with the Clyde catchment (pink) and the Kelvin catchment (blue), (map provided by the Clyde River Foundation, 2013).

The River Kelvin, a tributary of the River Clyde in central Scotland, is a candidate river system for active management in order to restore its productivity and biodiversity. The catchment of the Kelvin (Figs. 1, 2) comprises tributaries such as the Glazert, Luggie, and Allander Waters, as well as a number of smaller streams. Due to the shallow gradient of the river and its location in a low-lying valley, the Kelvin was originally prone to flooding of surrounding farmland and villages during periods of heavy precipitation (Gardiner & Armstrong, 1996; Matheson, 2000). In an attempt to prevent this, the river underwent extensive man-made alterations, beginning in the 1700’s, and as a result, the present-day course of the River Kelvin and many of its tributaries share few similarities with the historically meandering natural course of the river.

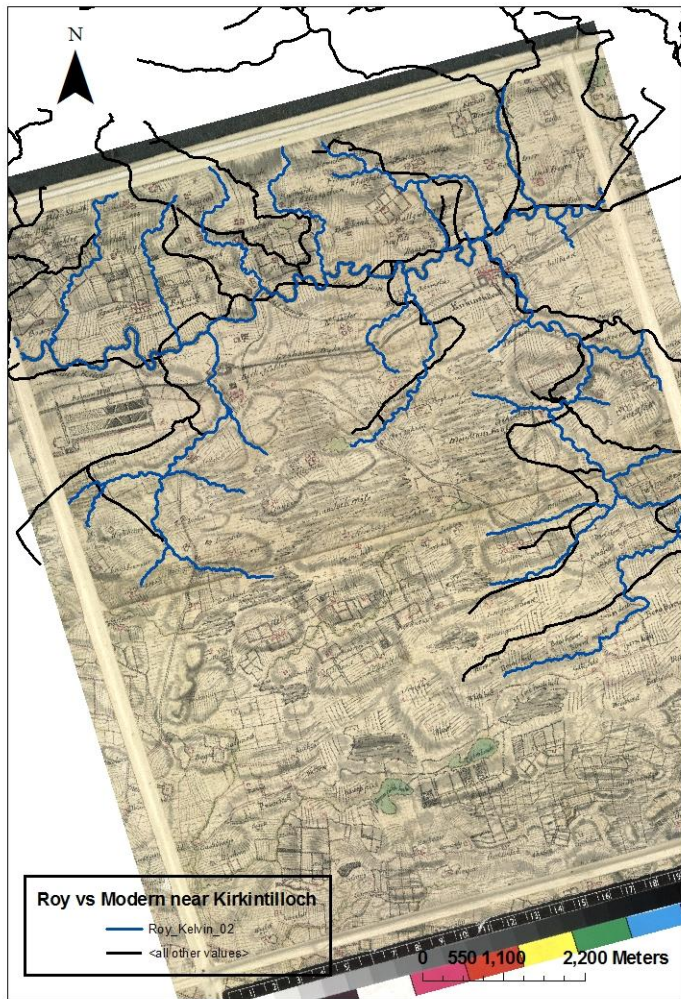
Fig. 3. Comparison of the River Kelvin system near Kirkintilloch as portrayed by the Roy Map (1752-1755) and the 2010 Ordnance Survey reported as "<all other values>" (map provided by the British Library, 2013).

By comparing the Roy Survey and the 2010 Ordnance survey, the total channel length lost in the entire Kelvin catchment was calculated to be 90.1 km, or 23%, since the 1750s (. 3; Table 1). Most of this loss occurred in the main stem of the River Kelvin, with its channel length (in 1752 – 1755) of 58.8 km shrinking to 20.4 km, a loss of 35%, by 2010. The Board Burn also suffered substantial changes, losing 36% of its total length and decreasing from 13.5 km to 8.6 km, over this period.

Comparison of the Roy Survey with the 1st edition Ordnance Survey highlighted the straightening of the main stem of the River Kelvin prior to the mid-1800s. These adjustments were made to manage flooding, create more available farmland, and provide water supply to the new Forth and Clyde Canal, for example from the Bothlin Burn (Matheson, 2000; Ross et al., 1986). In future research, a closer investigation could focus on the driving forces behind specific changes in different sections of the Kelvin catchment, providing more insight into the overall alterations that occurred.
